CRIMINAL JUSTICE SYSTEM UPDATE AND JAIL FACILITY ASSESSMENT FOR HAYS COUNTY, TEXAS

March 22, 2016

GRIFFITH MOSELEY JOHNSON & ASSOCIATES

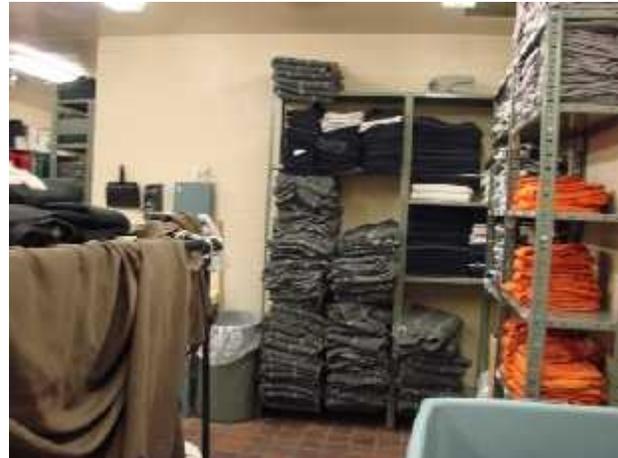
Inmate Laundry Room

The laundry room is small, with inadequate work surfaces and tight, awkward maneuvering space. The laundry room is open six days a week. The area is operated by inmates who are supervised by one officer.

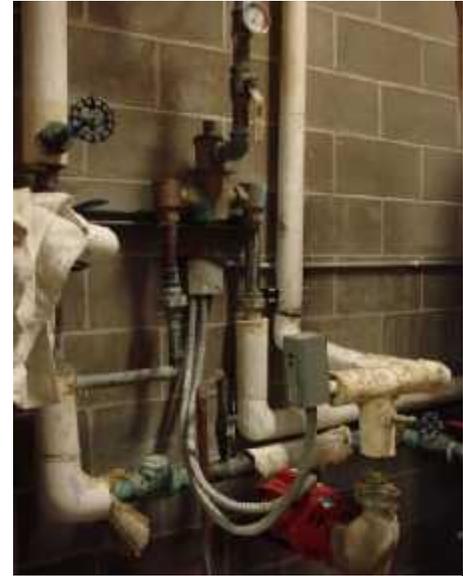
- Exposed copper lines and connections are patinaed, indicating possible light leakage caused by corrosion and pipe wall deterioration from the inside.
- A leak in the soil line that runs under the human resources training room floor can also be an indicator of deterioration of sanitary sewer lines.
- Security control station door control panels have overheated, emitted electric heat odors; on some occasions caused smoke; and have caught on fire. As a consequence, the electric operation of these doors has been disabled.

Patinaed Plumbing Lines and Fittings

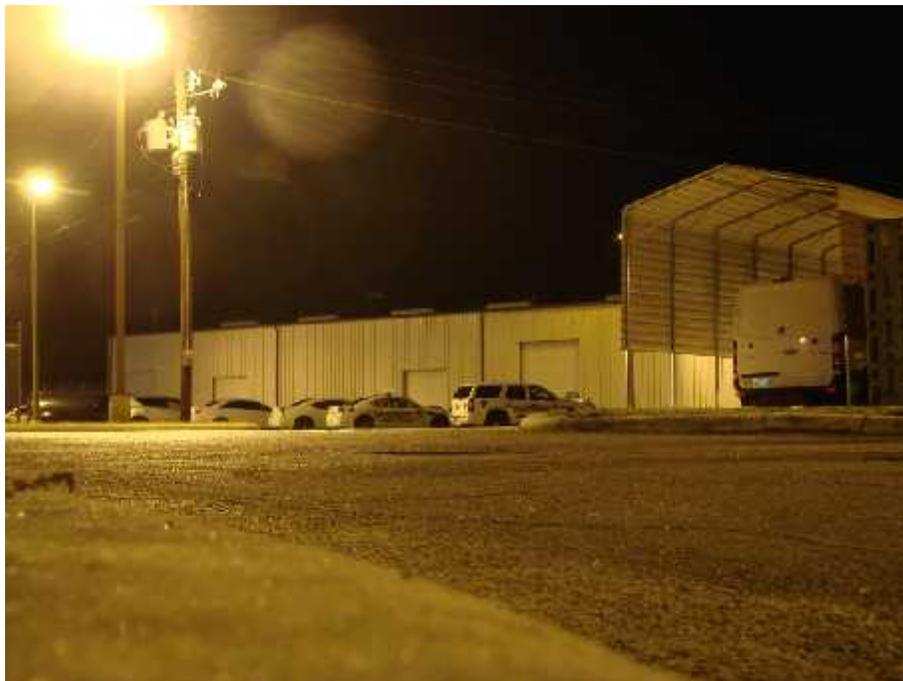
Facility Night Lighting

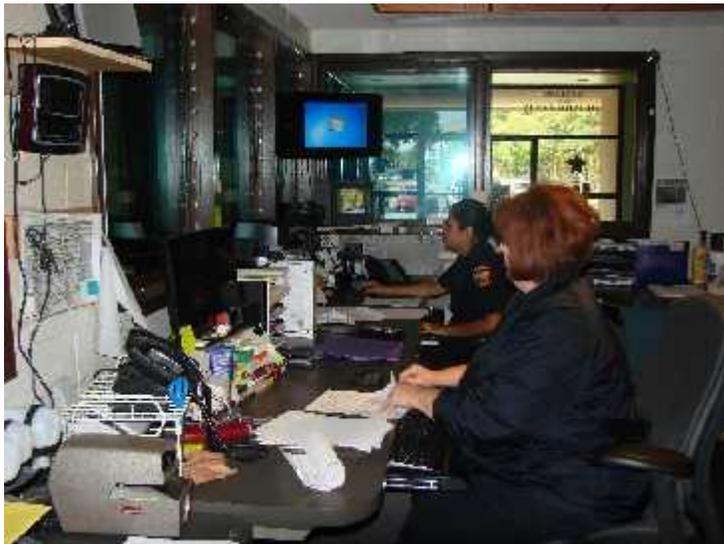
Direct security sight lines into the entry lobby from the bail bond/information/security control center are good. Sight lines of the storage locker alcove and public toilet doors are blocked. Lighting and HVAC for the lobby is good.

Bail Bond, Information, Lobby Security Control Station

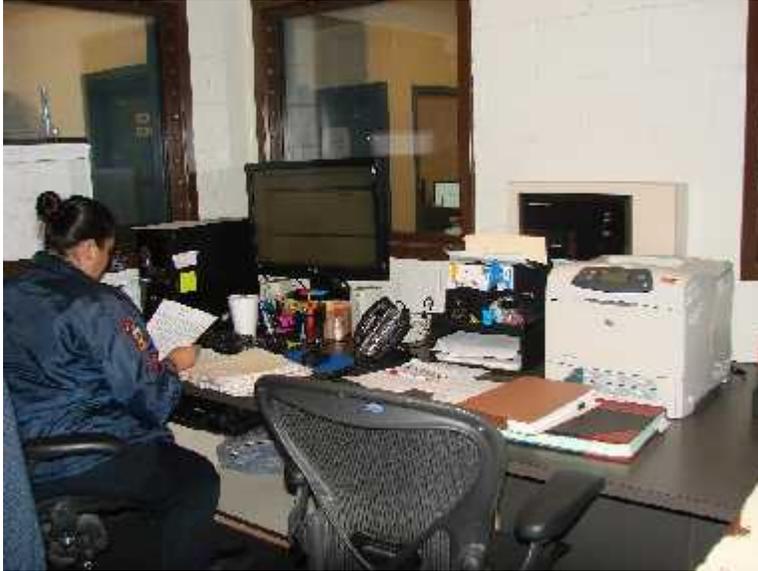
Bail Bond/Information, Lobby Security Control Station – Control Station Side

The bail bond transaction and processing area is not adequate. Too many functions are going on in this enclosed space. During periods when the bond window is open and staffing of the area is at minimum, interruptions to provide bond services and public information can cause interruptions and distractions to door control activities.

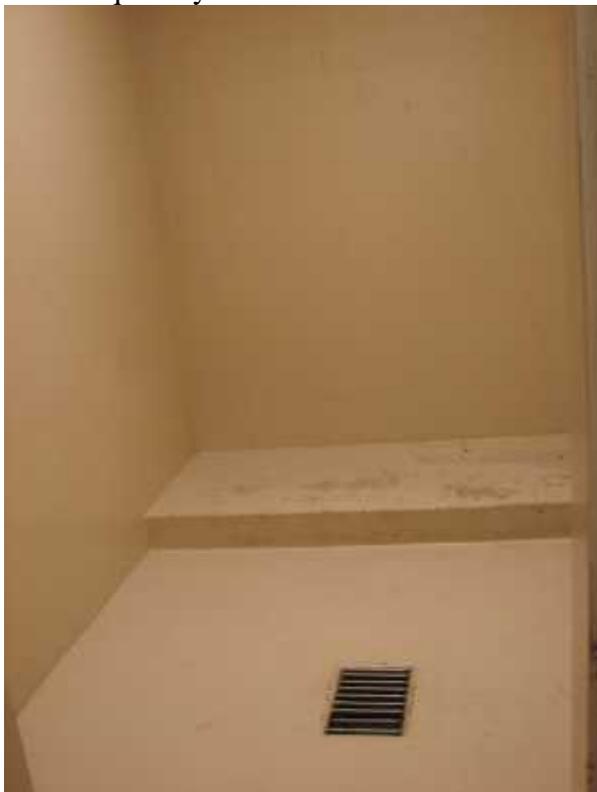
Suspected mental health inmates identified as “acute” are held in the padded (violent) cell. The cell does, to some extent, keep an inmate from harming themselves but has very limited direct sight line observation. Best practices indicate

Padded Cell

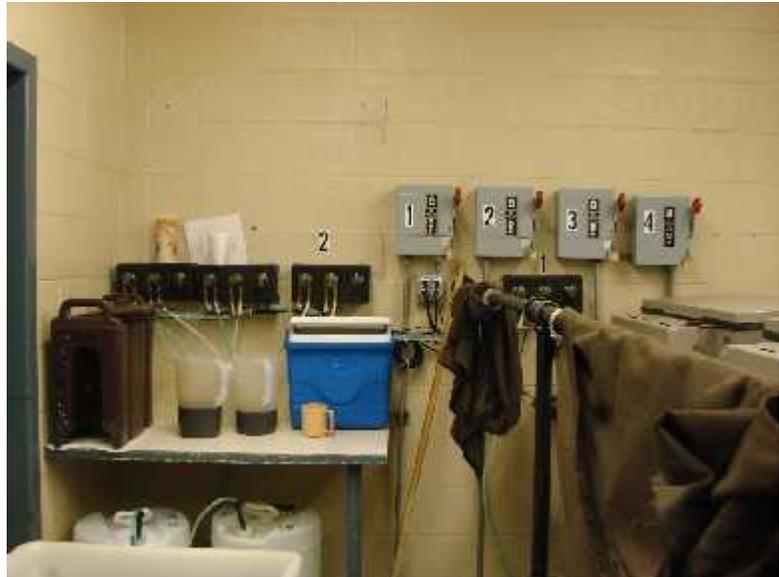
Exposed and unprotected storage and supply of cleaning chemicals within the unit is not a best practice. Exposed and unprotected water lines, waste lines and exhaust ducts are not best practices.

Exposed Chemicals

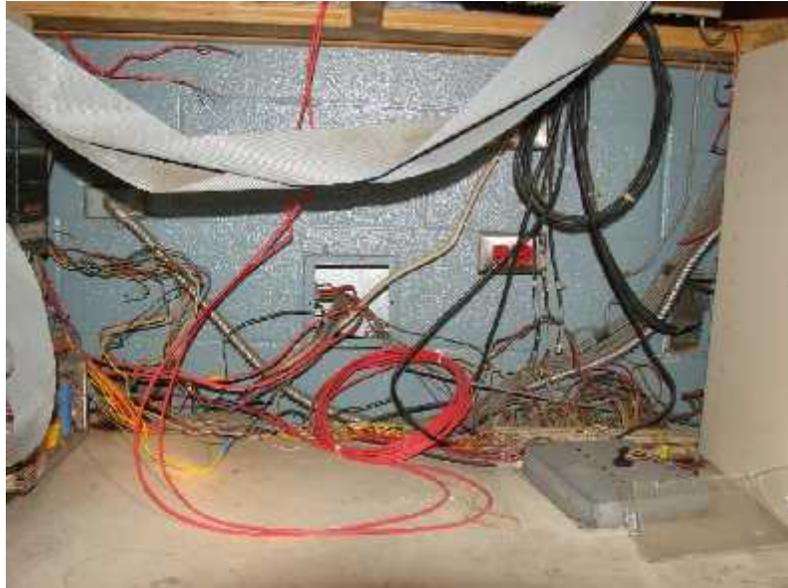
Problematic Control Console Wiring
