CRIMINAL JUSTICE SYSTEM UPDATE AND JAIL FACILITY ASSESSMENT FOR HAYS COUNTY, TEXAS

March 22, 2016

GRIFFITH MOSELEY JOHNSON & ASSOCIATES

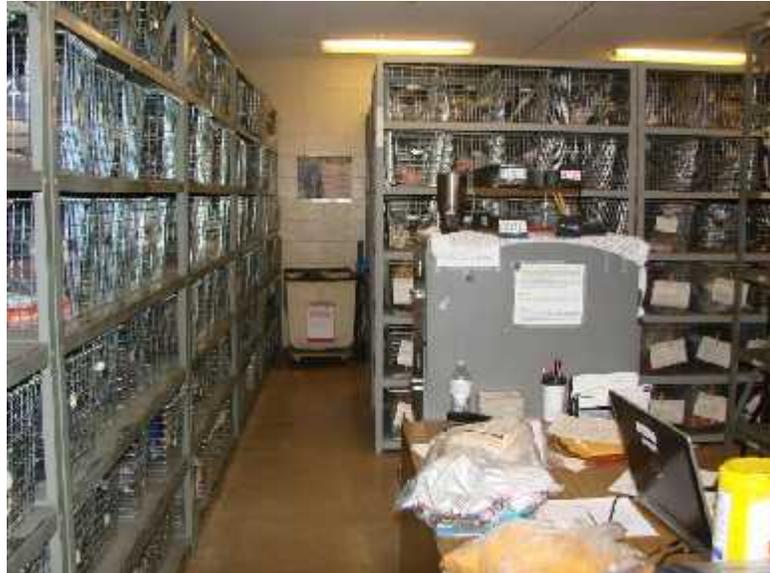
If the arrested person is held, he or she will be allowed to shower then dressed into a Hays County inmate uniform before being placed in the general population based on his/her classification level. However, if the arrested person is intoxicated or under the influence of drugs he or she will be placed in a separate holding area under careful observation until sobriety is reached.

The shower and dress out area is considered poor at best. The area is very small and outdated. The

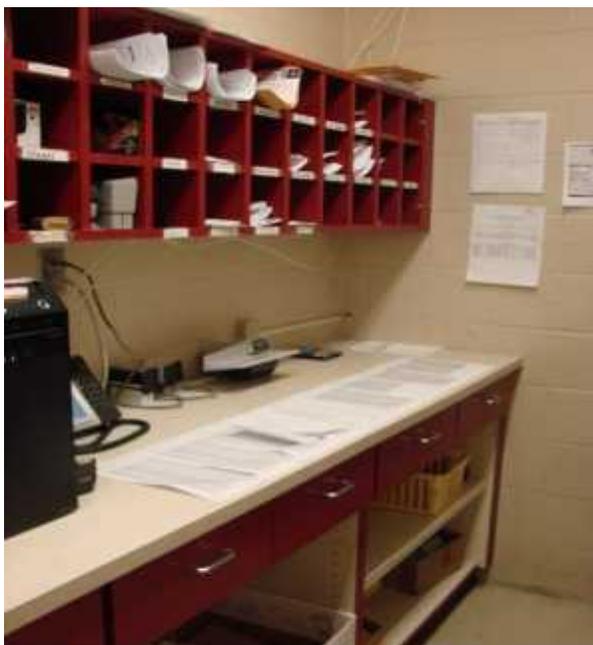
Mail Processing Room

The Hays County mail room space is very small. There should be dedicated space for processing mail with special ventilation designed to capture and dissipate airborne contaminants. This is an important safeguard for staff and inmates safety. In addition, secure storage for mail contents is important to avoid false claims of lost mail/property.

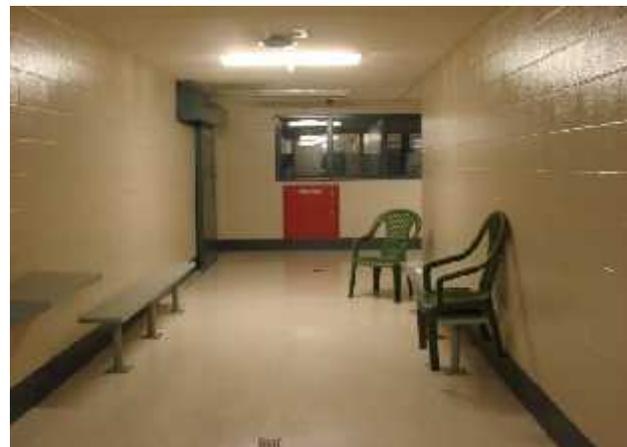
Example of Inmate Program Area

While the sheriff's department already operates services that target a wide range of needs, a lack of adequate program space is the primary constraint on the department's programs. There are weekly programs offered to inmates; however, there is no designated space to house the programs. GED, religious programs and counseling sessions are often conducted at cell doors or outside the housing area in the hallways.

It is critical that additional space appropriate for delivering inmate programs be identified in order to ensure the future success of these programs. There is a great need for multi-purpose rooms for education, counseling, and religious programming.

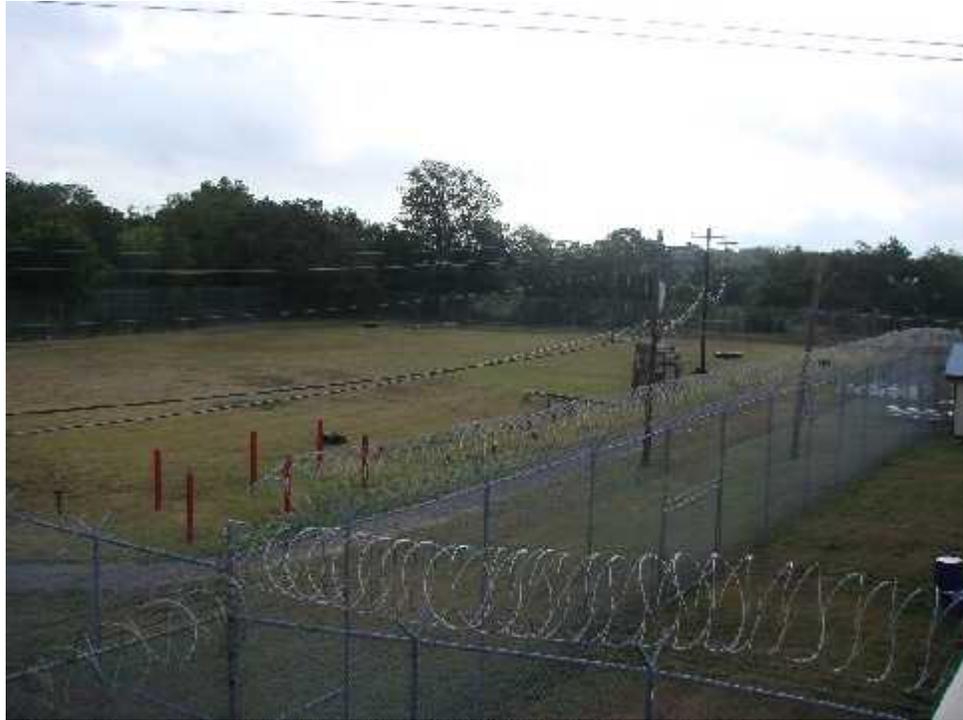
Defining Fence Lines

A ten-foot high chain link fence defines the east, north and west property lines. A 12-foot high chain link security fence with a coiled razor ribbon top defines the facility security perimeter along the east, north and west edges. The south edge security perimeter is defined by a combination of the security fence and the jail and safety building which straddle the

security fence line of the facility. The center vehicle gate through the security fence is electrically controlled from the jail central booking security control station. The east and west vehicle gates are manually operated and padlocked. Additional pedestrian and vehicle gates are located at certain points to provide access for fire apparatus and maintenance. Those gates are padlocked and manually operated. The area between the property line fence and security fence lines provides a buffer area around the building complex.

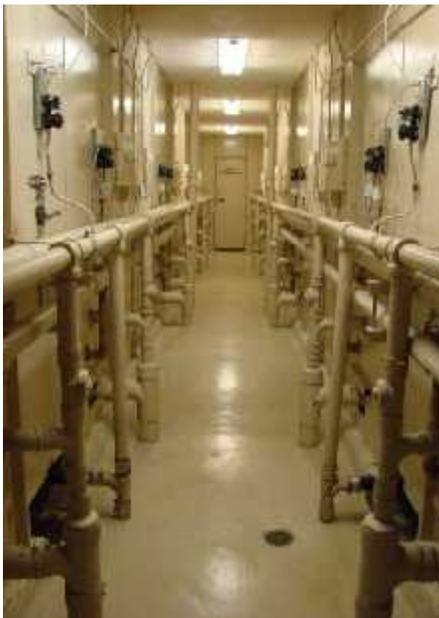
Utility corridor showing level of cleanliness

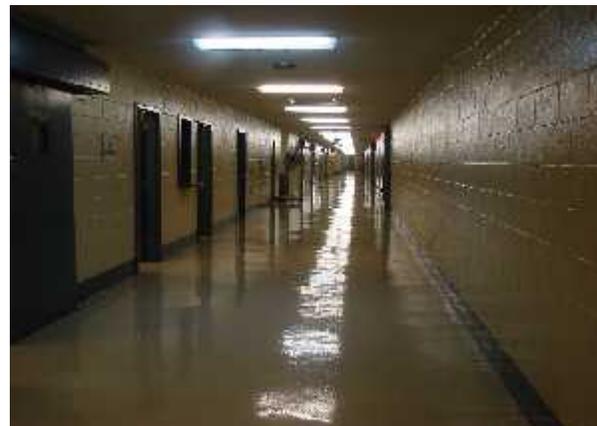
General Inmate Housing Spine Corridor

The circulation spine is the main thoroughfare for inmate movement to and from housing units as well as movement of support services carts. Approximately 360 feet long, the spine is lined with general population housing quads C and D on the east side; and infirmary, mail, commissary, laundry, kitchen, trash removal services and housing quad B lining the west side. The width of the spine is good. However being longer than a football field, the quality of direct security sight lines from the core security control station dramatically reduces at a distance of

approximately 150 feet. Beyond that point shapes and walking gaits can be identified but uniforms and faces cannot. Closed circuit television (CCTV) cameras at the one-third points and at the far end of the spine assist the security observation from the core control station. However, custody deputies working in the spine do not have good direct security sight lines from one end to the other.

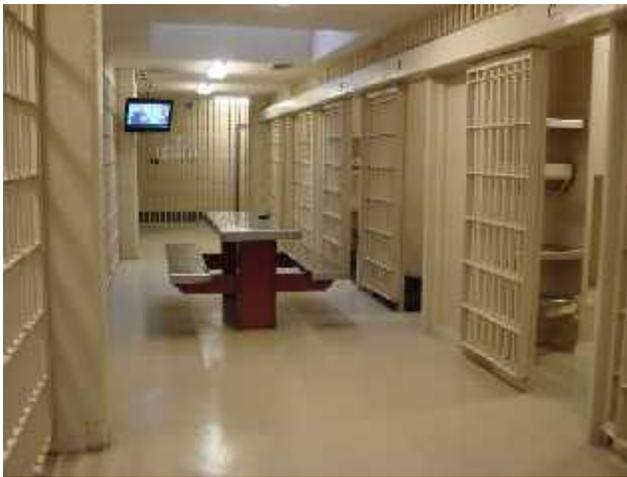
Presently the unit intended and designed for female custody is being used for youthful offenders (17-year-olds). On September 17, 2015, the 14-bed unit was holding seven inmates. General inmate population housing units throughout the jail were located, designed and constructed to

Quad A - Youthful Offender Holding

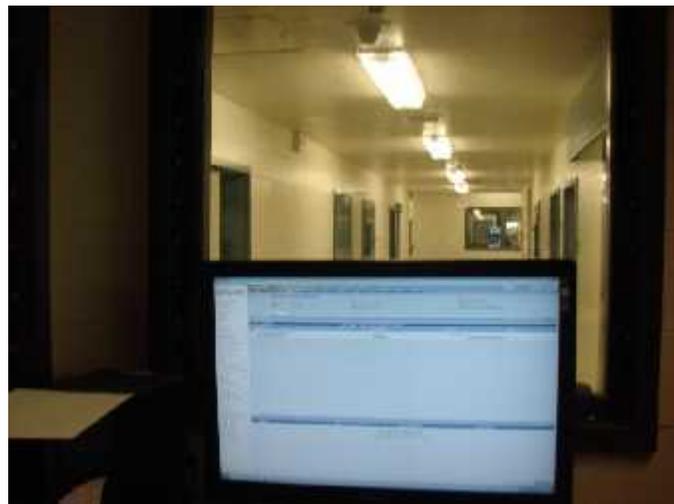
Due to the lighting level needs for the CCTV monitoring and other control station functions, the low light level in the space is very poor for the bail bond processing activities but adequate for security control activities. HVAC is good.

The bail bond transaction and processing area is not adequate. Too many functions are going on in this enclosed space. During periods when the bond window is open and staffing of the area is at minimum, interruptions to provide bond services and public information can cause interruptions and distractions to door control activities.

Bail Bond/Information, Lobby Security Control Station – Sight Line to Booking Control Station

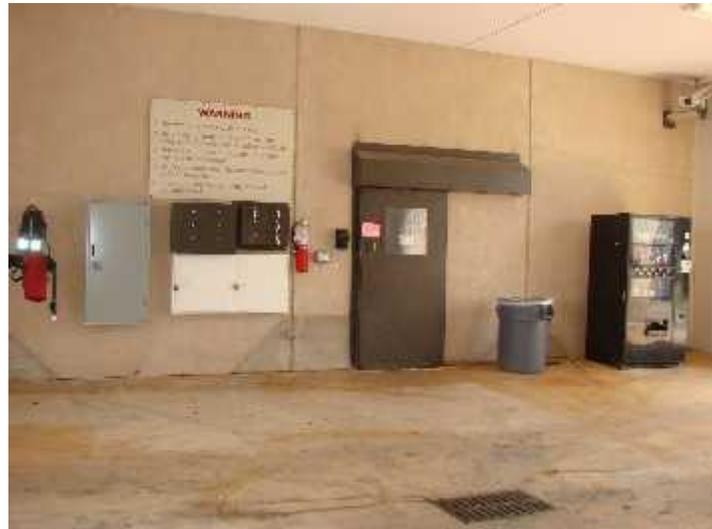
Booking Entry Door from Sally Port

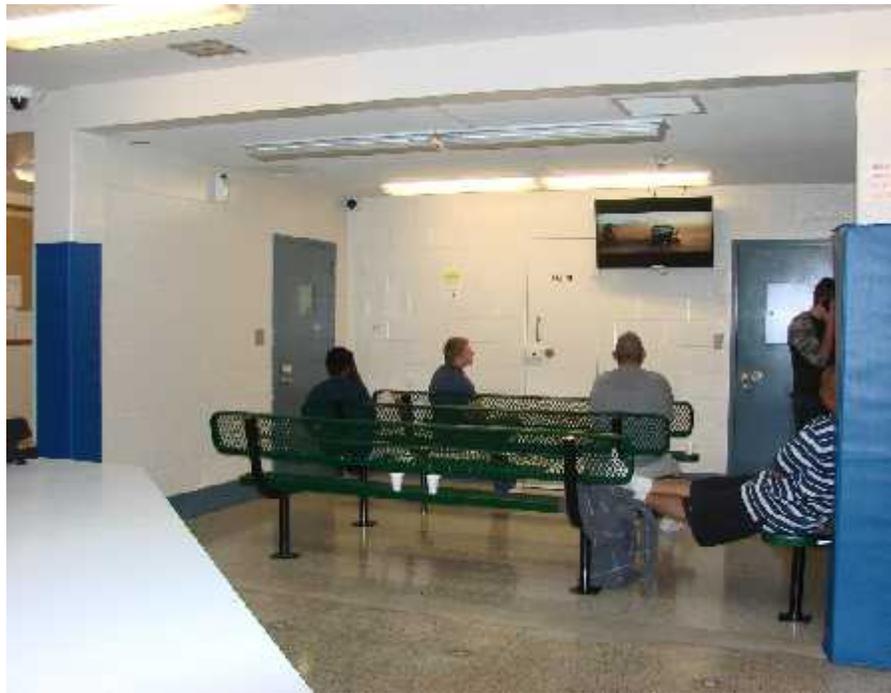
For Hays County, the booking area also functions as the processing-out and inmate release point. When inmates are released from the facility in groups for transfer to courts or other facilities, the intake process is stopped until the outgoing group is moved through the booking area and into conveying vehicles in the vehicle sally port. This occurs at least twice a day when the county courts are in session.

Open Seating in Booking Area

Booking and classification interviews should be done at interview stations in separate areas that provide appropriate levels of privacy and confidentiality. With present inmate demography, best practices suggest separate inmate intake and release routes. This would prevent the shutdown of the booking process when inmates in groups are being released for transfer to courts or other facilities.

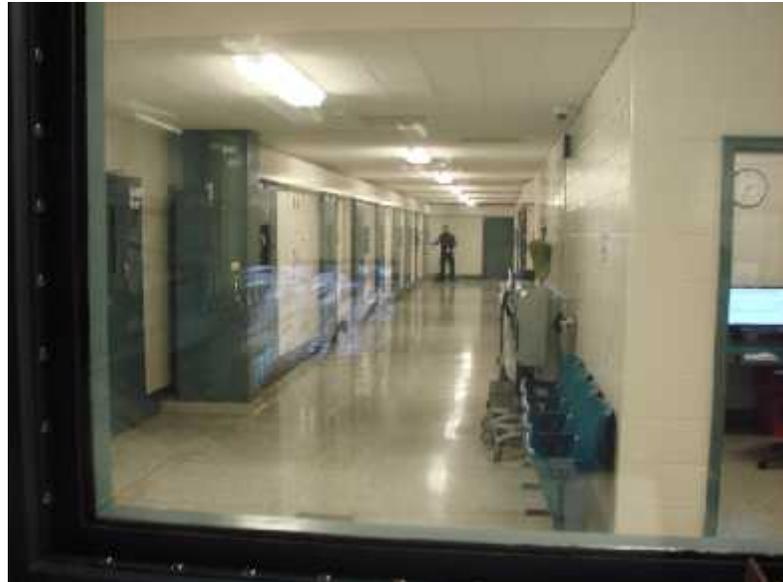
Suspected mental health inmates identified as “acute” are held in the padded (violent) cell. The cell does, to some extent, keep an inmate from harming themselves but has very limited direct sight line observation. Best practices indicate

Segregation Cell Corridor from Booking Control Station

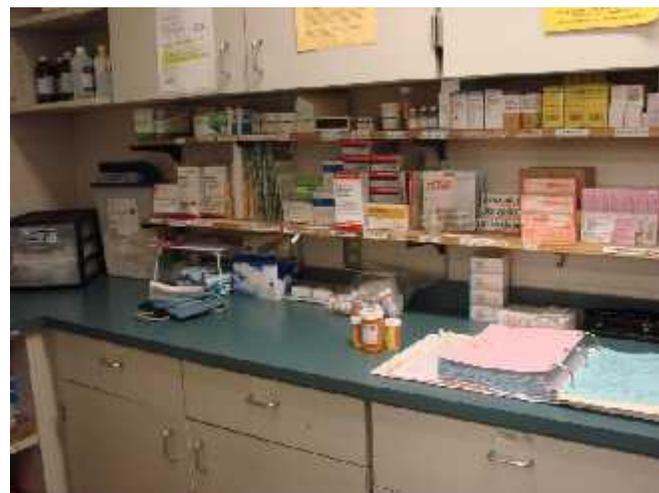
Medications Room

The nurse's station is outfitted with fixed desk, storage and filing cabinets and medical services counter equipment. Built-in drug storage areas above and below the drug sorting counter of the medications are not secured. The room is key locked. Additional work space and storage is provided by desks and wall cabinets placed along the wall in front of the nurse's station and examination room.

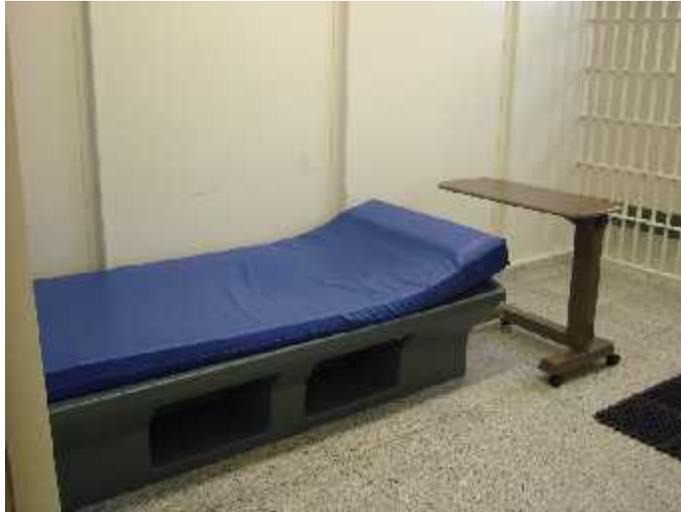
Medical Isolation Cell

CCTV coverage of the inmate waiting area and the infirmary work area is monitored by any security control station. Lighting of the infirmary is good. HVAC is good. None of the infirmary cells are equipped for negative pressure.

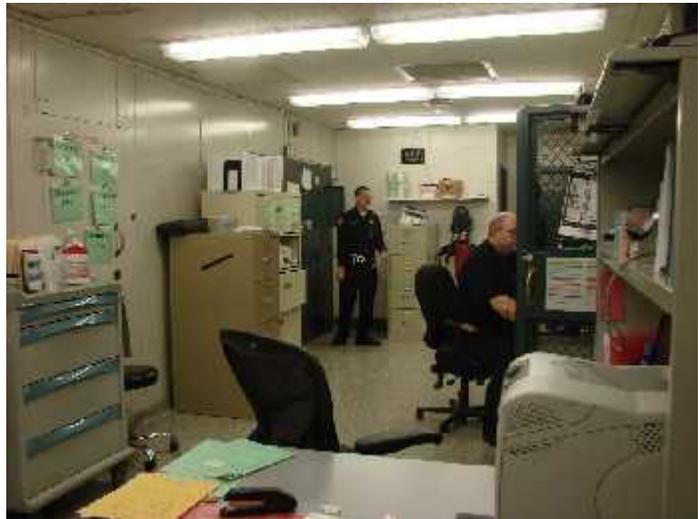
Infirmary Work Area

Presently the inmate waiting area is used as a second interview area. That area does not provide the privacy needed to secure confidential information needed from the inmate. A second inmate medical interview area is needed.

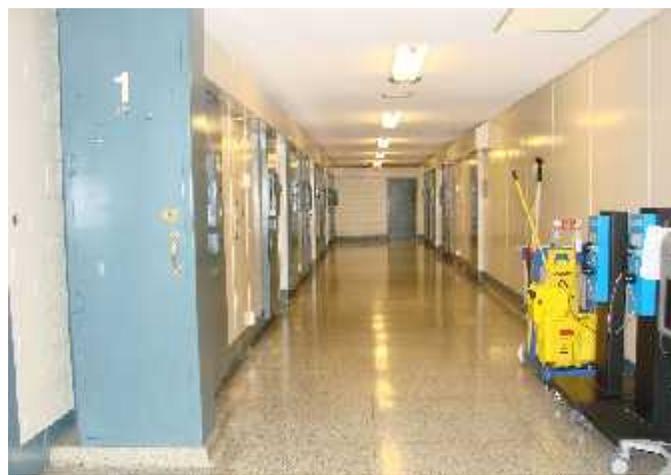
Segregation Cells Corridor

The sliding doors are reported to have been barricaded by inmates using a mop handle and continue to be problematic. Door operation failures are reported to occur often. Repair of the failures requires removal of the cable control mechanism covers. Over time the removal and re-installation of the covers has led to a point where it now requires two to three staff to re-position and securely install the panels.

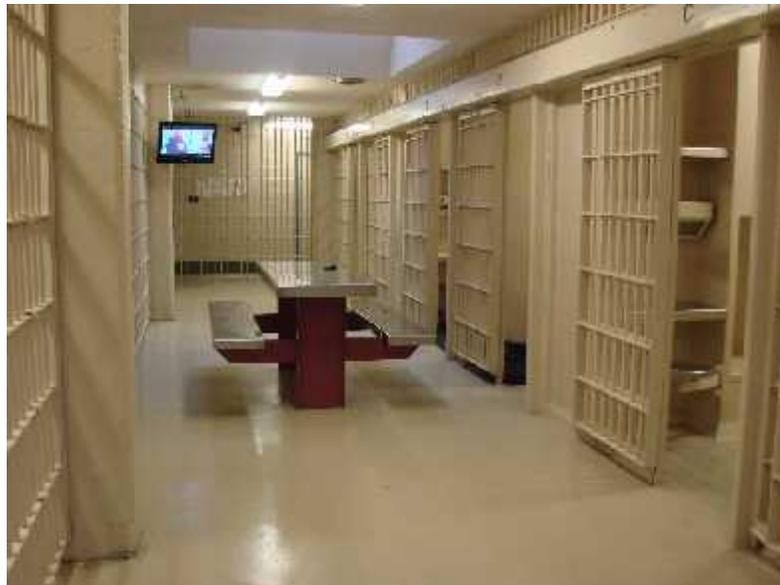
Quad A – Typical Dayroom

All cells and support spaces for the A Quad meet the Local Government Code VTCA, Chapter 511 and Texas Minimum Jail Standards.

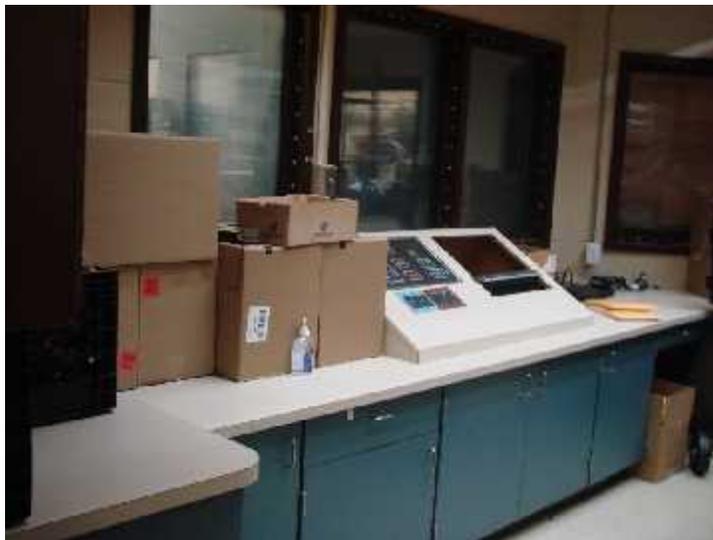
Disabled Visitors Guard Station Used For Storage

This visiting area is not in operation and its spaces have been repurposed. The multi-purpose/safety vestibule room is currently the chaplain's office. The guard/visitor entry door control center is deactivated and used for storage. Non-contact and contact visiting areas hold stored documents and items for the jail while the visitor waiting room is used for evidence storage.

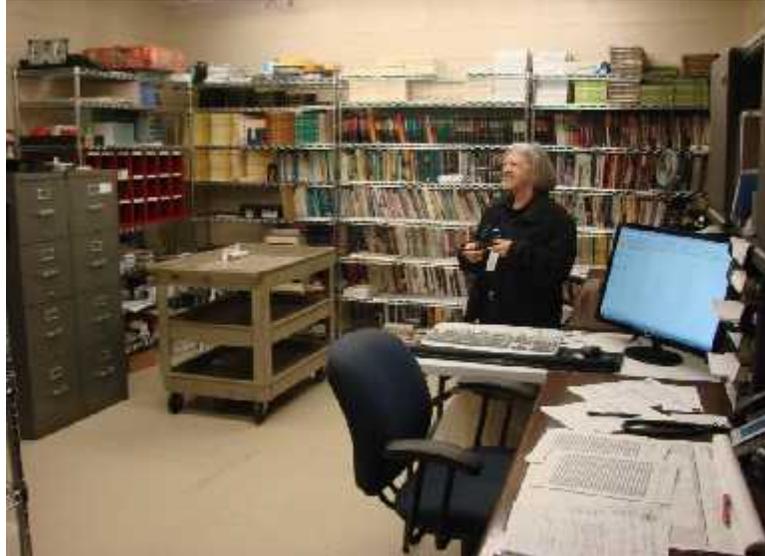
Figure 25
C Quad Intended Use and Operational Use

Chaplain's Office

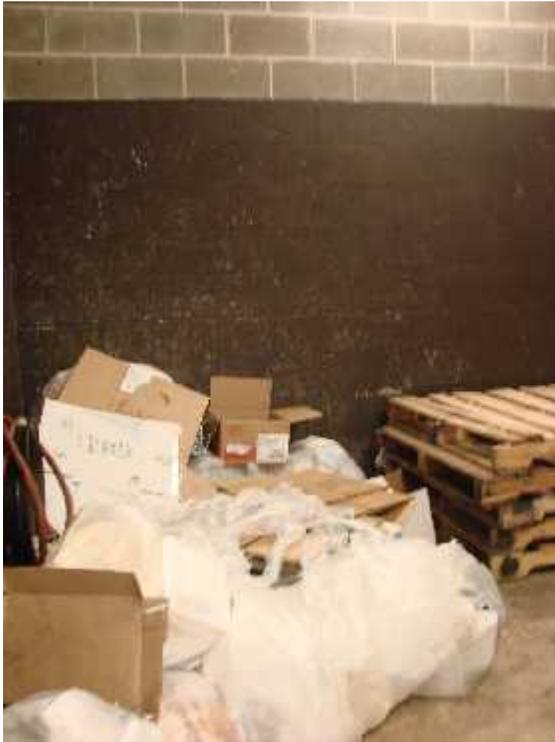
Trash Room

Trash for the entire facility is moved to the trash room for disposal. The trash storage area is barely sufficient for the facility and its present population level.

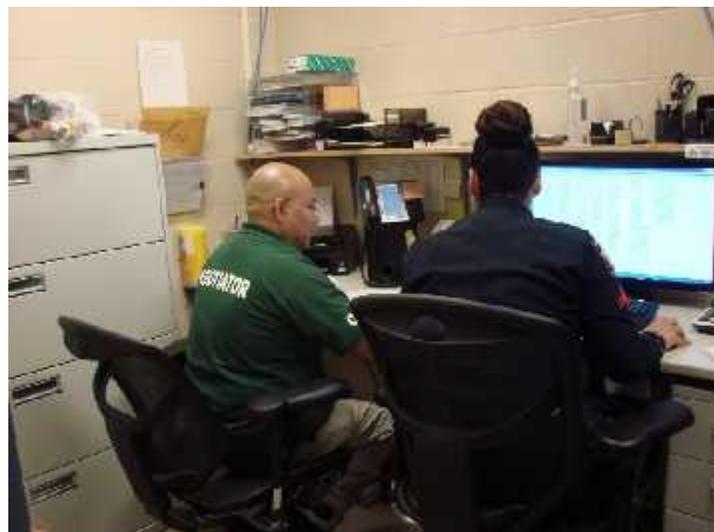
The commissary room is a small office area where commissary orders from inmates are processed. It is equipped with fixed desks, file cabinets, wall shelving and a commissary computer workstation. The space is shared by one or two commissary assigned deputies, a vendor employee, plus the support services corporal. The space is very cramped.

Commissary Office

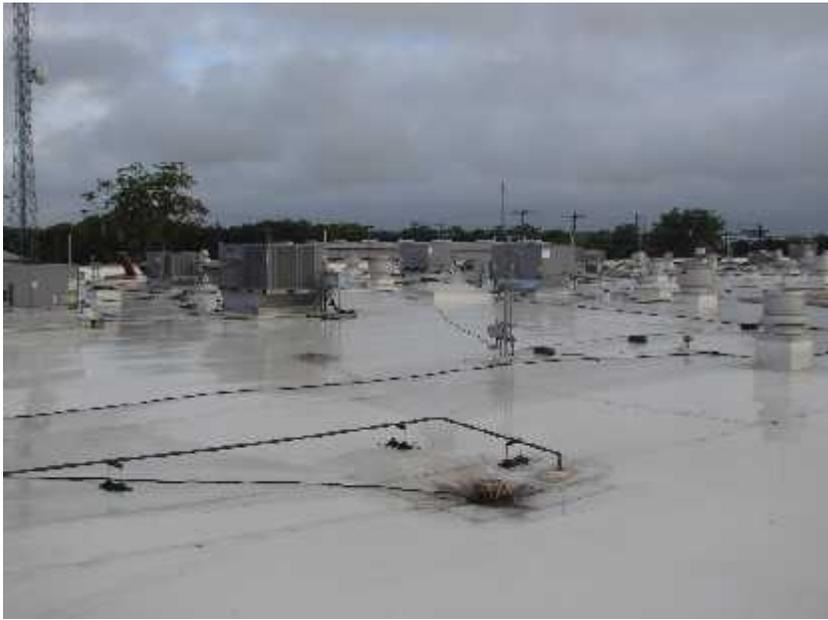
Rooftop HVAC Units

All of the roof-top units were replaced in 2010. Access to the units is by fixed steel ladders through a locked roof hatch. The access points are in designated locked electrical equipment rooms.

This method of heating and air conditioning is typically used for commercial big-box store and warehouse applications. It is also usually the least

expensive in capital costs but more expensive in operating costs. With each roof-top unit being a zone, there is no redundancy when failure of a unit occurs. There is no capacity of balancing air distribution from unit to unit. Smoke evacuation is performed by a separate mechanical smoke exhaust system.

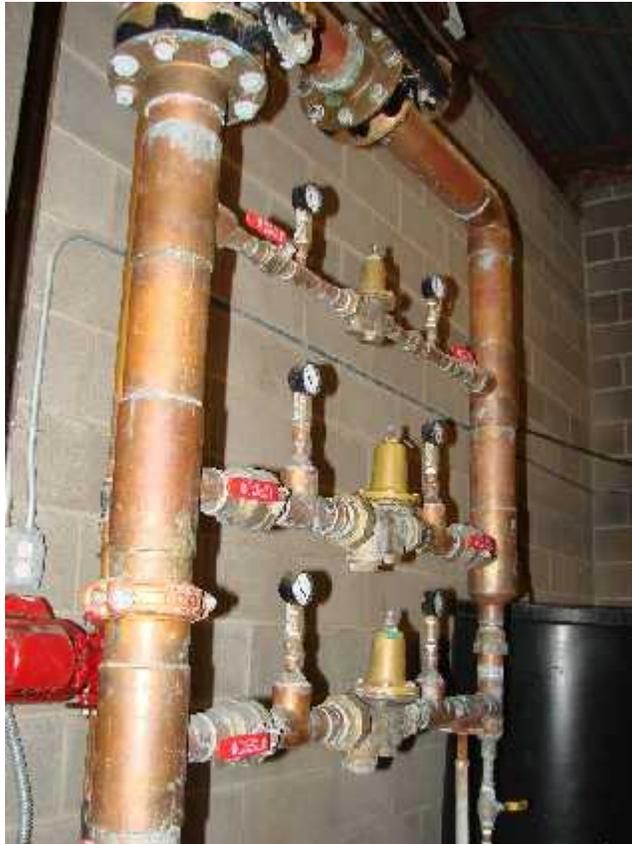
Without opening and testing water and sewer lines, the plumbing lines appear to be in good condition. Examination of maintenance and repair records indicate that repair requests for plumbing leak repairs and equipment replacement appear to increase as years go by. Observations during the building inspection are as follow below.

Water Service Main

Combination toilet/wash basin fixture connections are beginning to show some water leakage. Several water heaters have been replaced over the last few years. Exposed copper lines and connections are patinaed. This is an indication of possible light leakage caused by corrosion and pipe wall deterioration from the inside. The leaks in the soil line that runs under the HR training room floor can also be an indicator of deterioration of sanitary sewer lines.

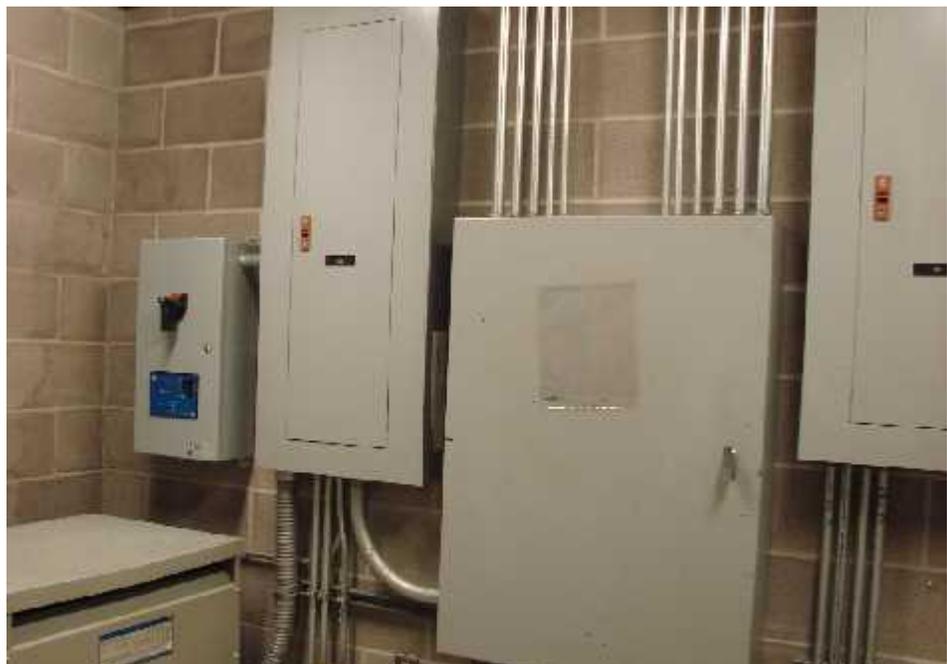
The electric gear and panels appear to be in good operating condition. Recently all of the florescent lighting fixtures were replaced with energy

Typical Electrical Control Panels

saving LED units. Examination of repair requests and reports indicate some failures. Frequency and the type of maintenance and repair of the building electrical items appear to be in the expected range for a 27 year old jail.
